**STUDY OF DAMAGED ROAD ALONG JALAN
SEMPADAN TELOK PANGLIMA GARANG**

JABATAN KEJURUTERAAN AWAM

DIS 2022

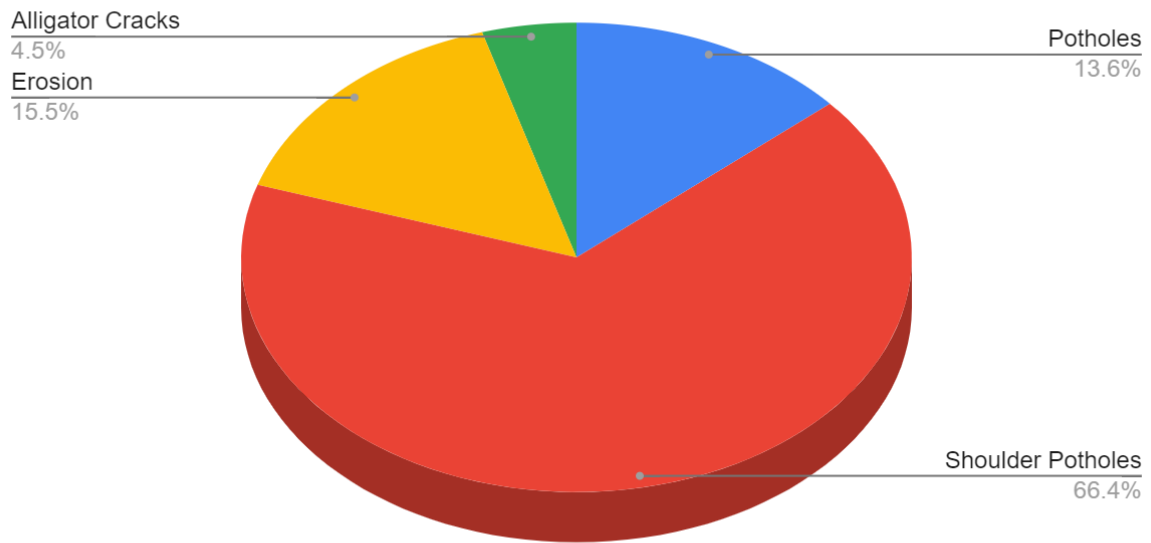
Figure 4. Percentage of damages that occurred.

According to the site inspection, there are 15 potholes, 73 shoulder potholes, 17 erosion spots, and 5 alligator cracks.

Figure 4 shows the percentage of every damage.

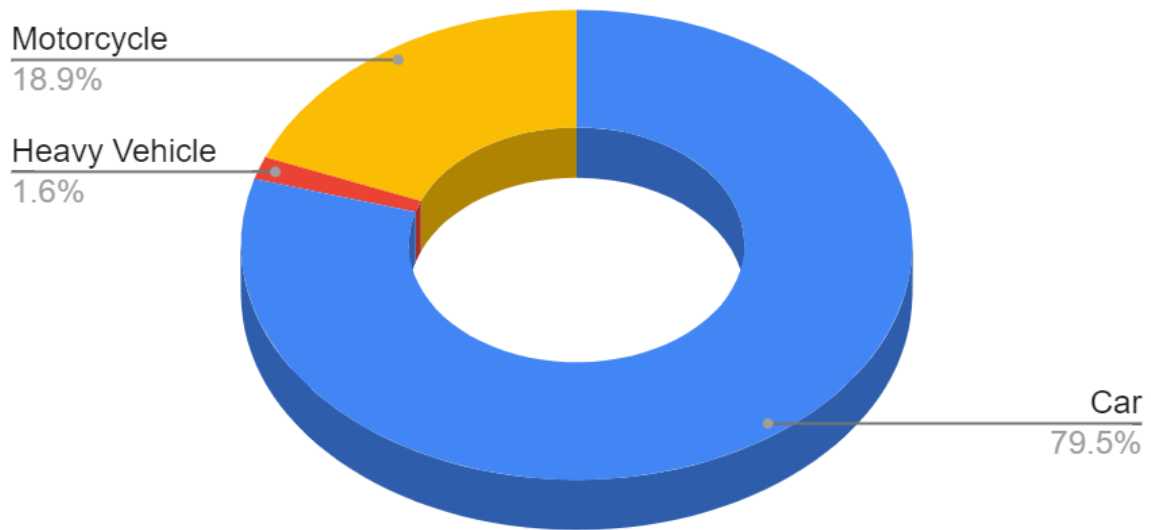
Figure 8. Classification of Road Vehicles.

The heavy vehicle population proportion is the lowest of any investigated segment at 1.6%. More over 80% of all traffic is comprised of cars, making them the most prevalent mode of transportation.

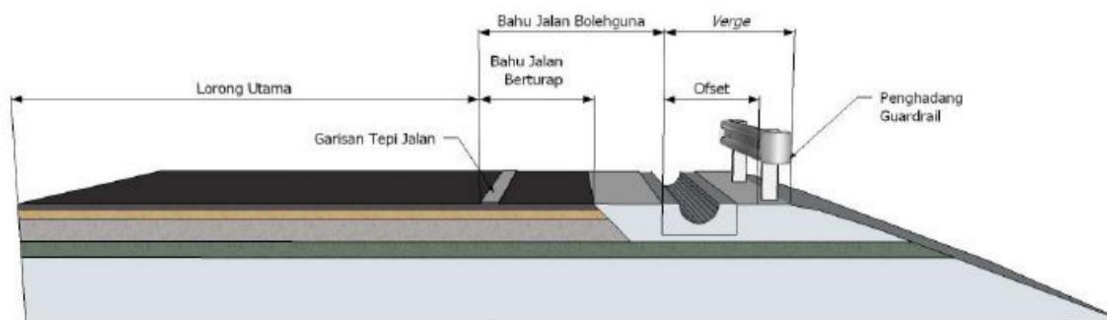
Figure 9. Paved road shoulder structure

Figure 9 shows the paved road shoulder structure.

It's possible that some or all of the road shoulder in question has been paved. The paved road shoulder along the significant road absorbs the weight of the vehicles. Thus its layout must match the exact specifications of the pavement structure. Each turn in the road must be planned according to the same turn structure as the main thoroughfares. Some examples of functions that highlight this trait and offer other benefits are as follows:

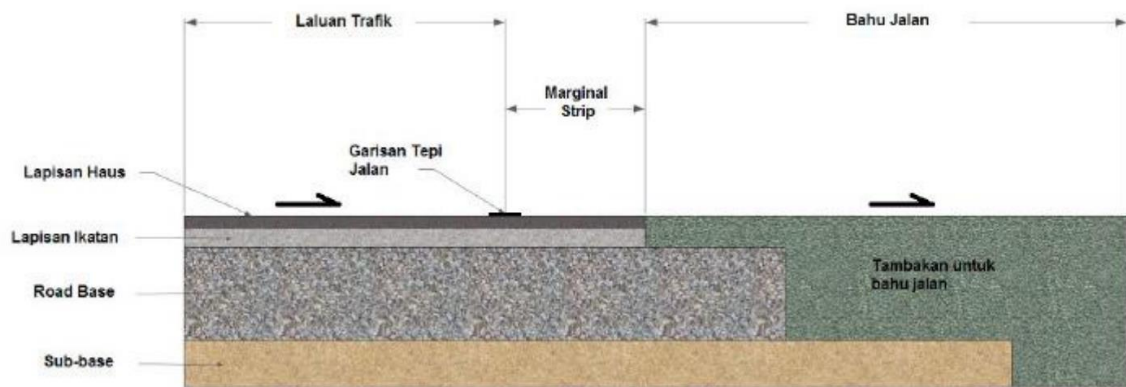
Figure 10. Unpaved road shoulder structure.

Figure 10 shows the unpaved road shoulder structure.

In contrast, a non-turfed road shoulder is the portion of a road's surface that is not levelled but instead is laid out by the road's existing structure, except the top layer, which is made of subbase material and is layered on top of lateritic soil. Mixing grass or layered aggregates with the road is not acceptable to make a road shoulder surface unsuitable for the roadway. The proliferation of these two types of roadside vegetation depends on roadside vegetation management practices.

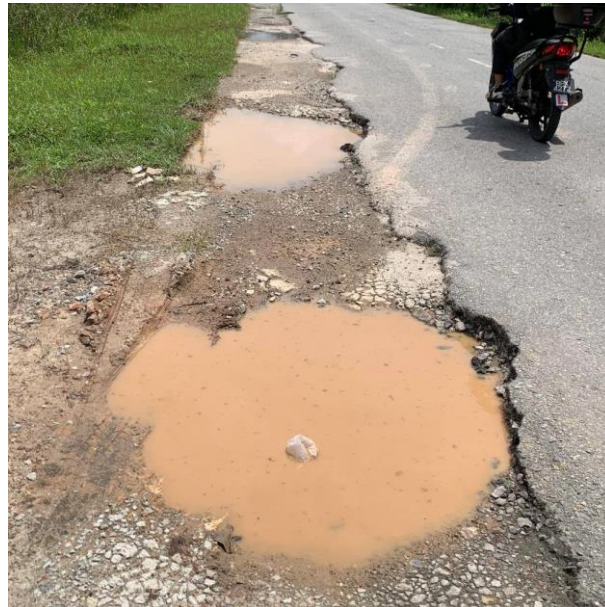
Figure 4.3.3. Road shoulder damaged with potholes and erosion

The road shoulder along Jalan Sempadan has bad potholes and erosion damage, as shown in figure 4.3.3. This will bring danger to road users, especially motorcycles. Excessive load factors, environmental variables (such as floods and the sufficiency of drainage channels), and poor road construction quality are the three main causes of road damage. Overloading a road significantly reduces the likelihood of it lasting as long as was intended. Overloaded roads are damaged before their time, which causes monetary losses. When buses or other large vehicles exceed their legal weight limits, it causes traffic load variations. The greater the frequency with which cars carrying excessive loads travel on a certain stretch of road, the shorter that stretch of road will last before its performance deteriorates. Water, an environmental issue, has a major impact on the state of the roads. The drainage coefficient, which depends on the quality of the drainage system and the saturation status of the pavement structure throughout the year, has been used to account for water in pavement structure design. Two functional condition characteristics of the road, the International Roughness Index (IRI) and the Surface Distress Index (SDI), are used in conjunction to determine the pavement quality (SDI). As a result of combining these two metrics, we can identify four distinct operational road situations (good, fair, slightly damaged, and severely damaged).

Next, it can be concluded that all the recommendations and methods obtained to achieve objective three have been stated in the writing of the report above. Among the most appropriate methods and guidance is to pave the road shoulders or use laterite soil type road shoulders.
