**STUDY OF DAMAGED ROAD ALONG JALAN
SEMPADAN TELOK PANGLIMA GARANG**

**MUHD SHAZNIEL SHAFIEQ BIN
SAHARUDDIN**

JABATAN KEJURUTERAAN AWAM

DIS 2022

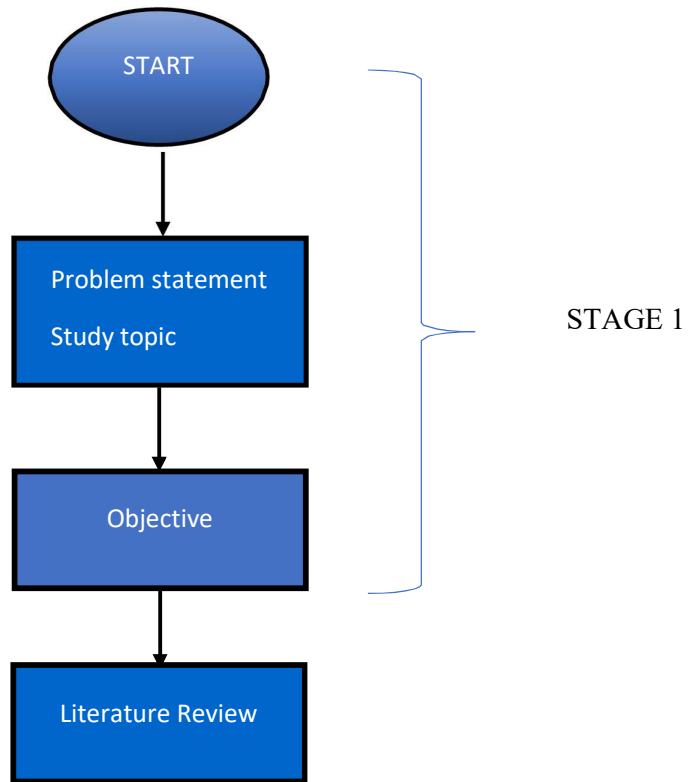
3.2.1 Method / Procedure

- The disclosure of the research problem's focal point**
 This issue is being made public in view of recent developments in the subject under consideration in this nation. Before beginning any research on a subject, it is crucial to raise awareness of the issue in order for the findings to be applicable to the outside world and to provide the general public reason for optimism.

- Objectivity and research design**
 Three goals must be achieved for this study to be deemed successful. This research's objectives also serve as a guidance as to where it has been effective and how it may assist the general public outside of academics in solving this issue. Additionally, because Jalan Sempadan is a residential neighbourhood, I concentrated my investigation within a 2.2-kilometer section of that street.

- Literature review**
 Literature reviews are necessary before conducting any research in order to gather data from previous studies that can be used to improve the quality of future studies. By referencing prior research, we can better understand the current issue and the prior research-backed approach to resolving it.

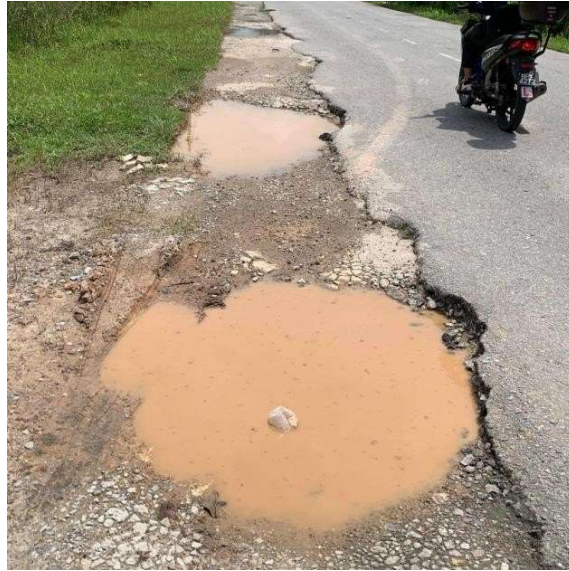
Figure 4.3.3. Road shoulder damaged with potholes and erosion

Figure 4.3.3 shows the damage that occurs alongside the road shoulder.

The road shoulder along Jalan Sempadan has bad potholes and erosion damage, as shown in figure 4.3.3. This will bring danger to road users, especially motorcycles. Excessive load factors, environmental variables (such as floods and the sufficiency of drainage channels), and poor road construction quality are the three main causes of road damage. Overloading a road significantly reduces the likelihood of it lasting as long as was intended. Overloaded roads are damaged before their time, which causes monetary losses. When buses or other large vehicles exceed their legal weight limits, it causes traffic load variations. The greater the frequency with which cars carrying excessive loads travel on a certain stretch of road, the shorter that stretch of road will last before its performance deteriorates. Water, an environmental issue, has a major impact on the state of the roads. The drainage coefficient, which depends on the quality of the drainage system and the saturation status of the pavement structure throughout the year, has been used to account for water in pavement structure design. Two functional condition characteristics of the road, the International Roughness Index (IRI) and the Surface Distress Index (SDI), are used in conjunction to determine the pavement quality (SDI). As a result of combining these two metrics, we can identify four distinct operational road situations (good, fair, slightly damaged, and severely damaged).

Next, it can be concluded that all the recommendations and methods obtained to achieve objective three have been stated in the writing of the report above. Among the most appropriate methods and guidance is to pave the road shoulders or use laterite soil type road shoulders.
